IPC04-0168

POST-INSTALLATION GEOTECHNICAL ISSUES ASSOCIATED WITH LARGE-SCALE HDD CROSSINGS

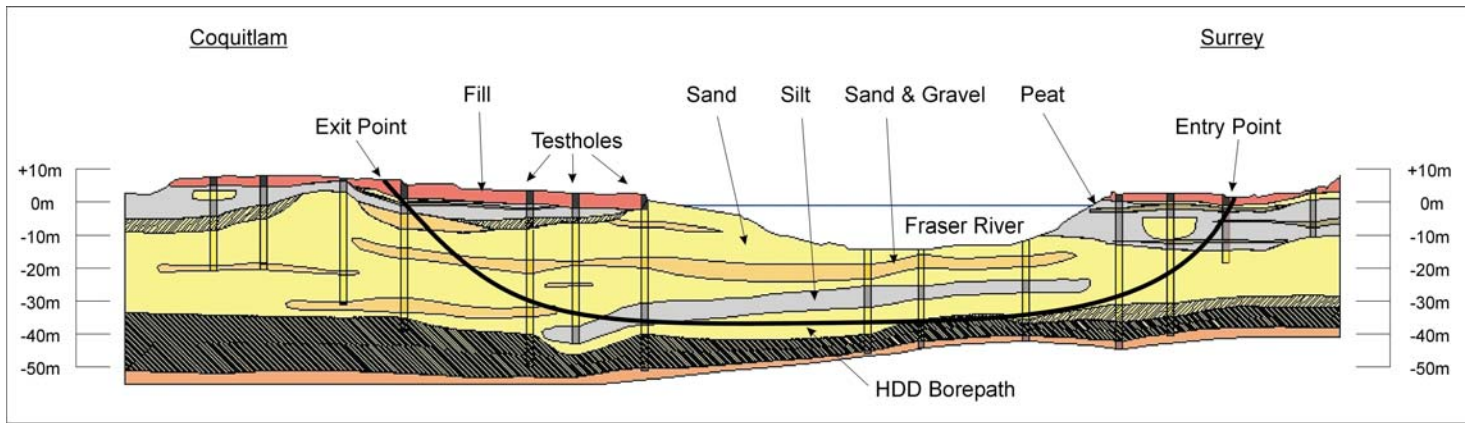
Figure 3. Schematic illustration of the Terasen Fraser HDD Crossing. Note 5x vertical exaggeration.

The results from the geotechnical investigation indicated that the crossing location was the site of sediment deposition by the Fraser, and that several interbedded layers of sands, silts and gravels were present. On the inside bank of the river (within the CN Rail yard), thick deposits of peat were also found, consistent with a lowland overbank flood depositional environment. Across the majority of the test sites, the soils were determined to be loose to very loose (SPT blow counts less than approximately 10) over the top 10 – 12m before more dense materials were encountered. Due to the presence of the Fraser River and proximity to the Pacific Ocean, a relatively high water table was also encountered, and which was subject to some tidal fluctuation.

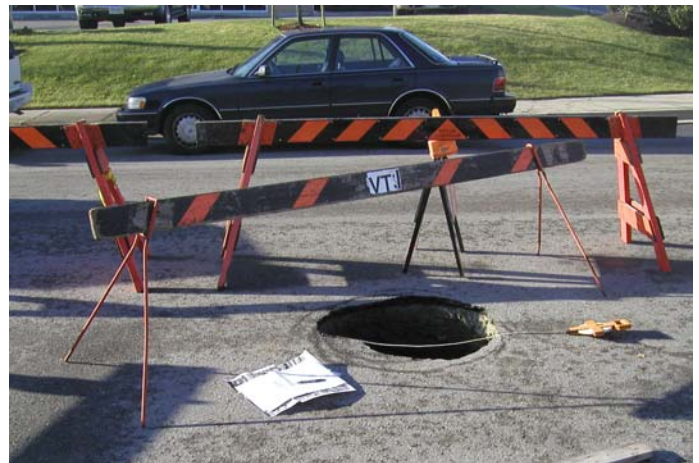
In October 2003, following heavy rainfall and localised flooding, over a period of four weeks, three sinkholes opened up just short of the exit point, on either side of the intersection of two heavily trafficked roads, and posing concern to the City of Coquitlam for both the road and underground services in the immediate vicinity of the sinkholes. These sinkholes were either directly over or within 4m of the newly installed pipeline, and ranged in size up to 4m in diameter and 2m deep; depths similar to that of the local water table.

Figure 4. Photograph of a sinkhole in Coquitlam, B.C.

1. That over the month following installation, the bentonite mud left in the borehole following pullback deflocculated, leaving the large annulus unsupported and the loose soils to collapse into the annulus.
2. That circulation may have been allowed to continue during the time when the source of the problem for the loss of the guidance signal was being discovered. At this time, the HDD was relatively shallow and close to the exit point with the stationary jetting resulting in a loss of some of the loose overburden material.
3. That with the large rainfall, increased surface water runoff and groundwater flow may have infiltrated the borepath, washing the bentonite mud into the coarse granular layer noted to have caused a loss of circulation during the drilling, and leaving the annulus unsupported.

Following these observations, a two-stage mitigation plan was developed by BGC in conjunction with Terasen and the City of Coquitlam, in which, for the first stage, a light-weight flowable fill mixture was injected from a distance back towards the river side of the sinkholes in an attempt to fill any remaining void space in the annulus along the pipe. This was intended to prevent any unsupported sections of borehole along the pipe from collapsing in the future. This first stage was successfully completed by utilising PVC pipe, which was

required due to its limited abrasive and puncture potential against the new pipeline. Through a combination of jetting, vacuuming and top-hammering, the PVC pipe was installed down to the depth of the annulus over the centreline of the pipe, after which the flowable fill was pumped under controlled volumes and pressure into the annulus. Pumping continued until the flowable fill was observed entering the excavation at the exit point, thus ensuring that the annulus was completely filled.

The second stage of the ground improvement program consisted of compaction grouting the soils overlying the pipeline in an attempt to stiffen any areas where voids may have started migrating to the surface. This stage also utilised PVC pipe to protect the new pipeline. As for the first stage, the PVC pipe was installed down to the depth of the pipeline, although for this stage, installation was made in parallel holes to either side of the pipeline. Once installed, measured volumes of compaction grout were injected at a controlled pressure as the PVC pipe was extracted. Injection was stopped prior to reaching the surface to prevent jacking of the ground surface.

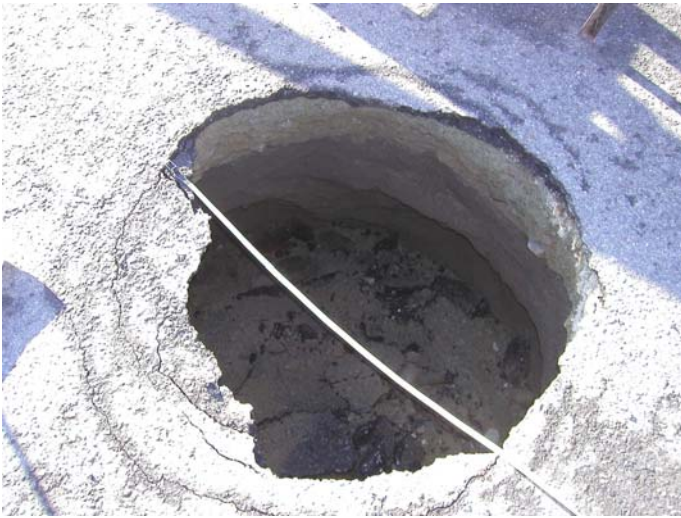
Figure 5. Photograph illustrating the vertical nature of the sinkholes observed in Coquitlam, B.C.

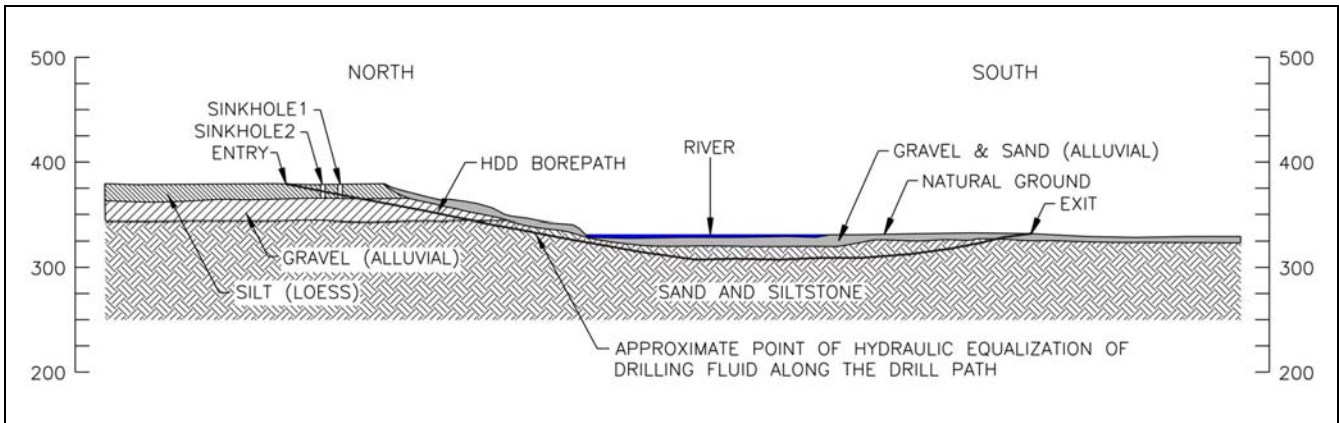
Figure 6 provides a schematic illustration of the crossing, and shows the completed path of the HDD. From an entry point at the top of the left (north) valley slope, the HDD descended beneath the slope and then the river to the exit point on the far (south) bank of an alluvial river terrace. As a result of the geometry of this crossing, an elevation difference on the order of 50m occurs between the entry and exit points, leaving most of the drill path beneath the left valley slope above the hydraulic equalization level, which was controlled by the exit point mud pit. This portion of the bore, about 260m long at an 11 degree downward incline, was, therefore, unsupported during the drilling and reaming passes.

Figure 6. Schematic illustration of the North-Central Argentina HDD Crossing. Note 3x vertical exaggeration.

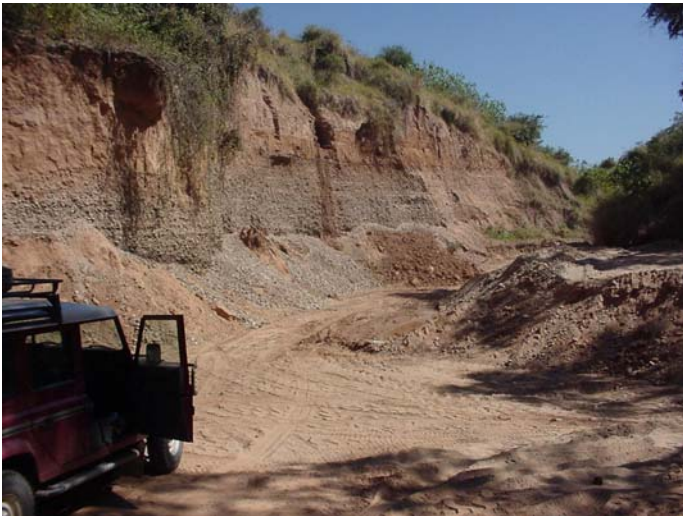
Figure 7. Wind blown sandy silt (loess) overlaying cobble gravel with sand lenses at a tributary valley near to the crossing.

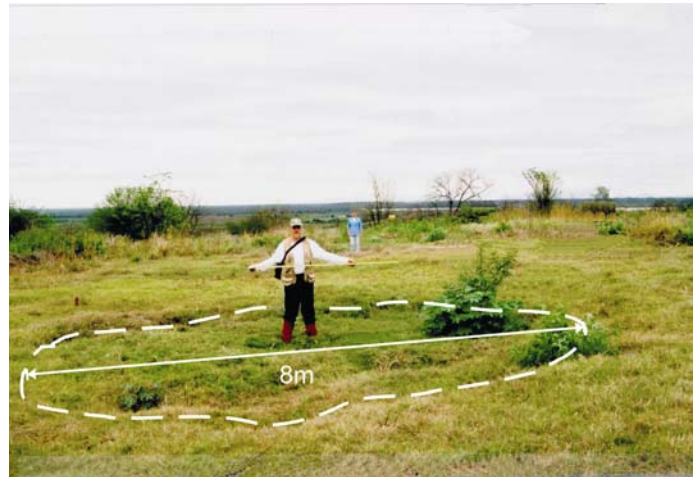
The subsided surface expressions of the filled sinkholes more than two years later are illustrated in Figure 8. This southward view along the surface trace of the drill path shows one of the authors standing in sinkhole #2. The individual in the background is standing in the centre of sinkhole #1. The diameter of both sinkholes expanded during backfilling, indicating that the cavities were substantially larger than initially appeared at the ground surface.

Figure 8. Surface expression of Sinkhole #2 (foreground) and Sinkhole #1 (beneath background individual) two years after construction.

The act of simple backfilling with the pipeline already installed almost certainly caused high bending strains where the fill material loaded the pipeline section that was spanning the bottom of each sinkhole. Excessive curvature, including strains that may be approaching yield, wrinkles and ovalities may all be present, and is likely the root cause of the calliper pig becoming stuck. In addition, impact loading caused by the cobbles being dropped onto the unsupported pipe may have caused coating damage and dents.

Examining the construction history indicates that the sinkholes likely resulted from collapse and loss of ground where the unsupported HDD path passed through the cobble gravel and its contact with the overlying loess. The borehole annulus has likely enlarged laterally in the cobble gravel and this resulted in a collapse propagating vertically into the loess until the resulting 'chimney' extended to the ground surface.
