CONTROLS ON STABILITY OF THE THOMPSON RIVER LANDSLIDES

M.J. Porter¹, K.W. Savigny¹, T.R. Keegan², C.M. Bunce³, and C. MacKay³

¹BGC Engineering Inc., Vancouver, British Columbia, Canada

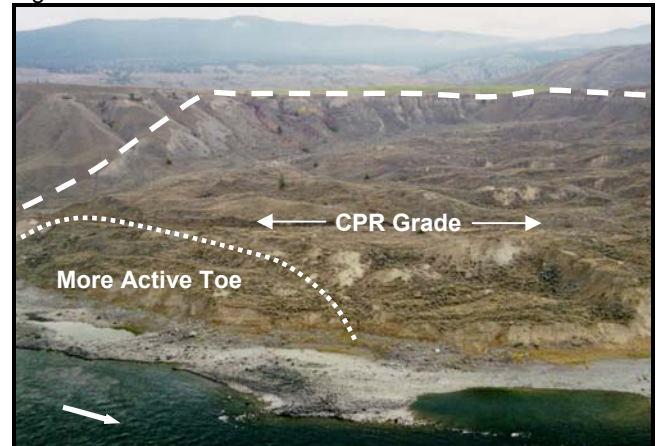
Figure 3: Northern Half of North Slide

The North Slide is located immediately north of Black Canyon on the left side of Thompson River (Figure 3). Movement along 150 m of the toe of the North Slide in October 2000 resulted in between 5 and 15 cm of settlement at the CPR grade. A detailed geotechnical investigation, including drilling, test pitting, instrumentation, and historical airphoto comparison was conducted.

The program identified a thick deposit of stiff, high plastic glaciolacustrine clay underlying silty glacial till. The glaciolacustrine deposit contained layers of softer brown clay, stiffer dark grey clay, and grey silt. Test pits through a toe bulge on the river floodplain revealed preferential shearing through the soft brown clay.

A management strategy including the installation of tip-over posts (linked to the rail signals) and ongoing monitoring was adapted to reduce the potential for train derailment and to gain a better appreciation of the retrogressive behaviour of the landslide. To date, it has been possible to manage movements at the rail grade through normal maintenance and track lifting operations.

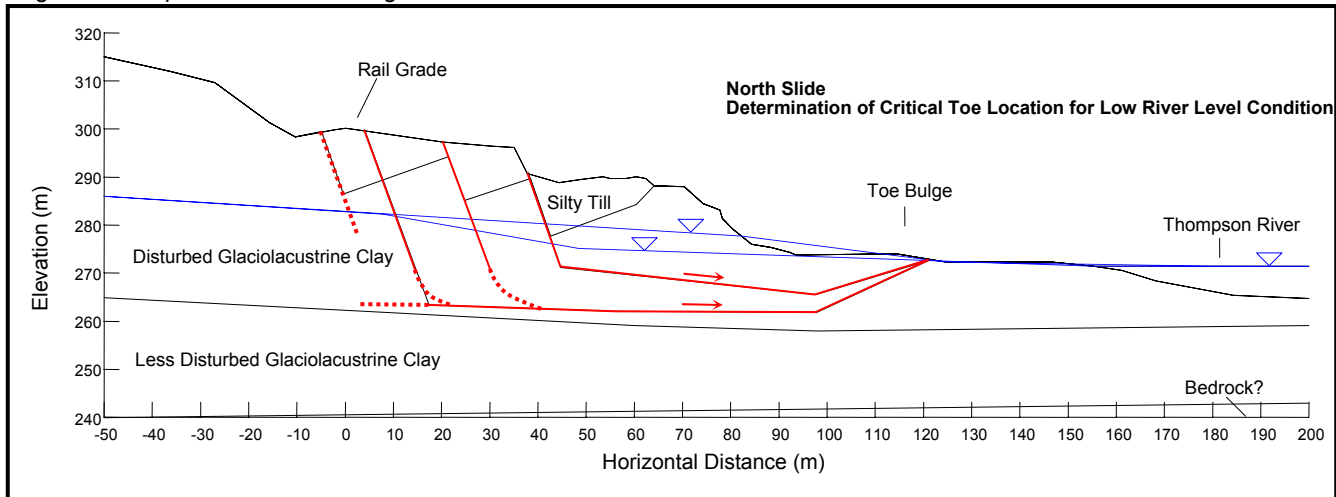
Figure 4: Simplified Section Through Toe of North Slide

Slope monitoring showed evidence of two shear zones located 25 and 35 m below the rail grade (approximate elevations 265 and 275 m above sea level (asl)), with peak observed movement rates on the order of 150 mm/yr (Figure 4).

A comparison of airphotos taken between 1928 and 1997 suggests that the slopes below the rail grade have been quite active, likely in response to ongoing bank erosion. In some locations, historical bank erosion rates have averaged up to 0.7 m/yr.

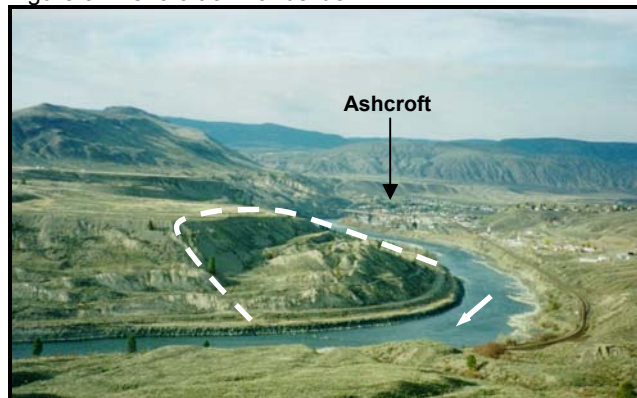
Figure 5: Ashcroft 51 Landslide

The Ashcroft 51 Landslide is located approximately 2 km south of Ashcroft and is traversed by the CN Rail line (Figure 5). An inspection of the slide toe in February 2001 identified 100 m of tension cracks along an old toe berm below the rail grade. In response, a detailed geotechnical investigation was conducted.

A shear zone was identified approximately 4 m below a contact between silty glacial till overlying laminated silt and high plastic glaciolacustrine clay. The elevation of the shear zone was approximately 274 m asl. Surface observations and slope inclinometer data indicated the movements were retrogressive in nature, with movement rates below the rail grade approximately an order of magnitude higher than those above the rail grade. Tip-over posts were installed and a monitoring program implemented as a temporary risk management strategy.

Monitoring in the fall of 2001 showed a dramatic increase in slide movement rate and a 6 m extension to the toe berm was constructed to improve the stability of the rail grade. Movements slowed above the rail grade, but have continued to date near the crest of the toe berm. The face of the toe berm extension was constructed with a relatively steep slope to minimize impact on fish habitat and

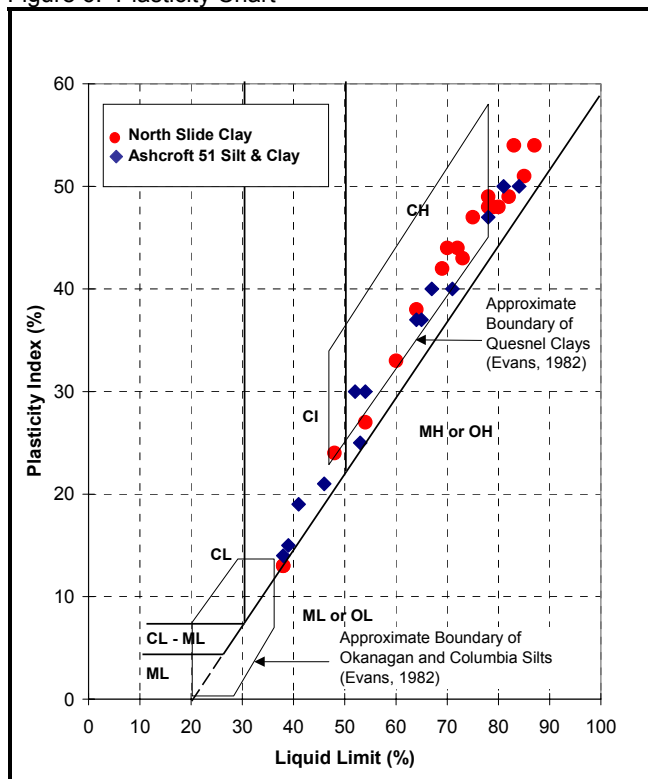
Figure 6: Plasticity Chart

Core samples of the clay revealed rhythmically laminated light brown high plastic clay, grey plastic clay and grey silt, characteristic of a deep glacial lake deposit. Occasional thin (<2 mm) black sand seams were encountered. Typical Atterberg Limits are illustrated in Figure 6. Clay-size fraction often exceeds 70%, with clay activity in the range of 0.6 to 0.9, suggesting illite clay mineralogy.

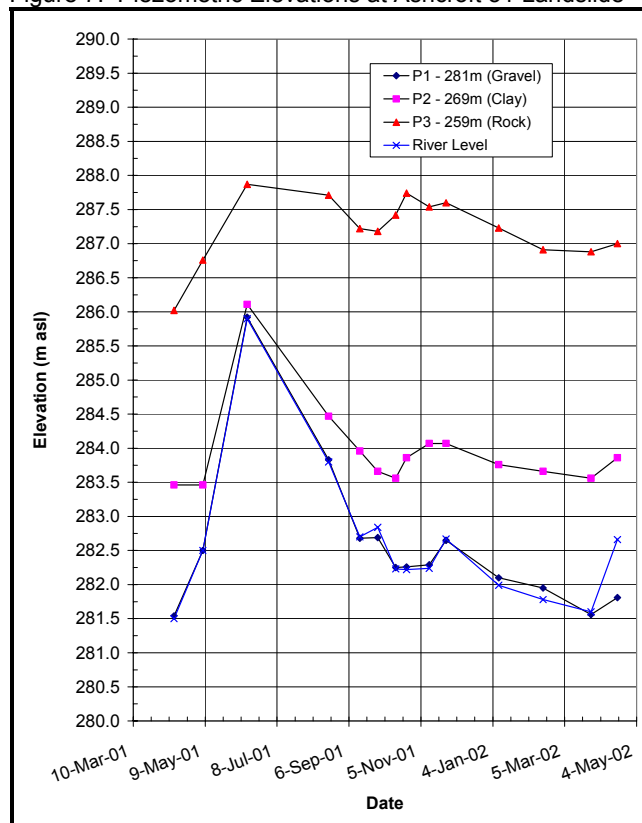
Figure 7: Piezometric Elevations at Ashcroft 51 Landslide

At North Slide, the upward hydraulic gradient within the glaciolacustrine clay ranged from about 0.3 (June 14, 2001) to 0.4 (October 24, 2001), while at the Ashcroft 51 Landslide, the upward gradient ranged from 0.2 (June 13, 2001) to 0.4 (October 24, 2001). In the fall, pore pressures near the top of the glaciolacustrine unit drop more quickly than those at the base of the clay, resulting in larger upward hydraulic gradients.

As indicated in Figure 7, the piezometric elevation along the base shear surface at Ashcroft 51 (elevation 274 m asl) was significantly higher than river level throughout the fall and winter of 2001. Therefore, when river levels rose in spring and summer, the mass of the water provided an increase in the stabilizing force at the toe of the landslide.

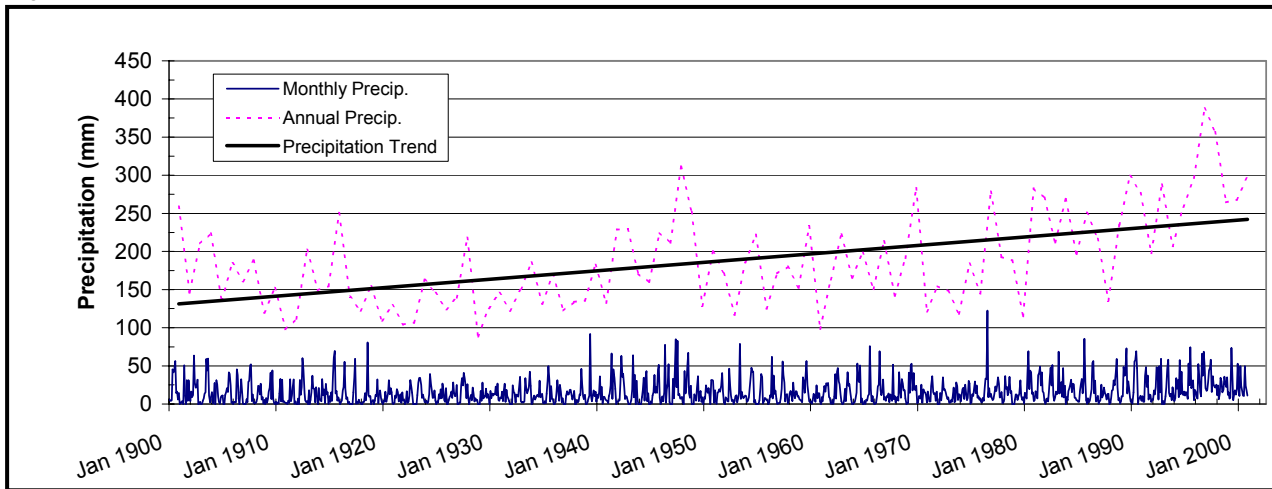
Figure 8: Precipitation Data for Kamloops, BC

Precipitation data from climate stations near Kamloops, British Columbia, show a significant increase in precipitation levels since the beginning of the 20th century (Figure 8). Thus, despite improvements in irrigation practice, the soils at the base of the Thompson River landslides may still experience abnormally high pore pressures which contribute to ongoing landslide activity.

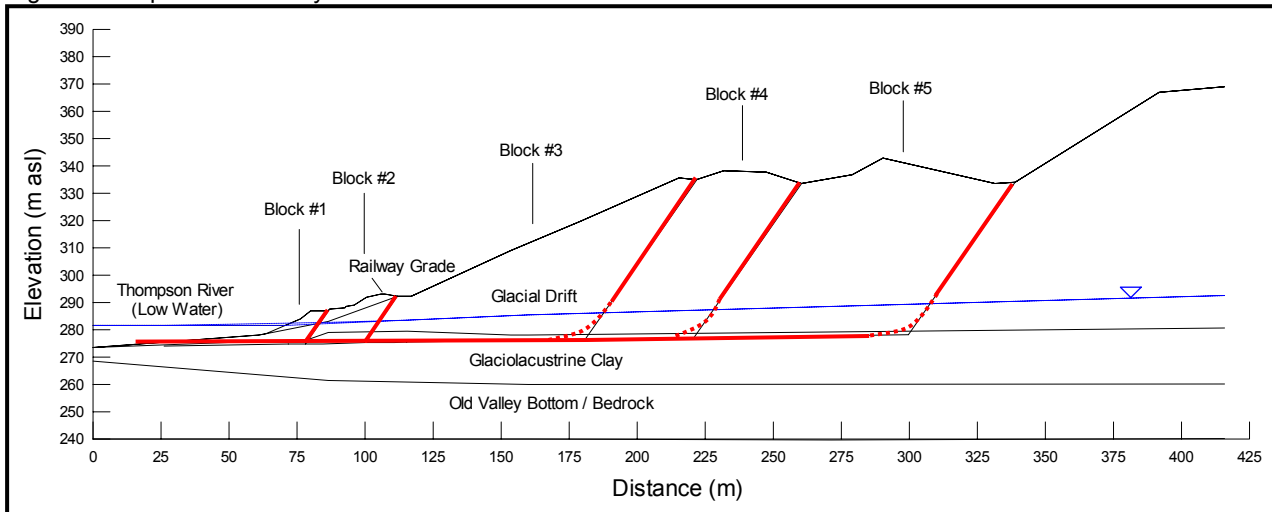
Figure 9: Simplified Geometry for the Ashcroft 51 Landslide

Stability analyses were undertaken to evaluate the influence of the annual cycle of rising and falling river level and piezometric elevations on stability of the toe of the Ashcroft 51 Landslide. The factors of safety of the lower three blocks in Figure 9 were evaluated at a number of time intervals between April 13, 2001 and March 25, 2002. The results are plotted in Figure 10.

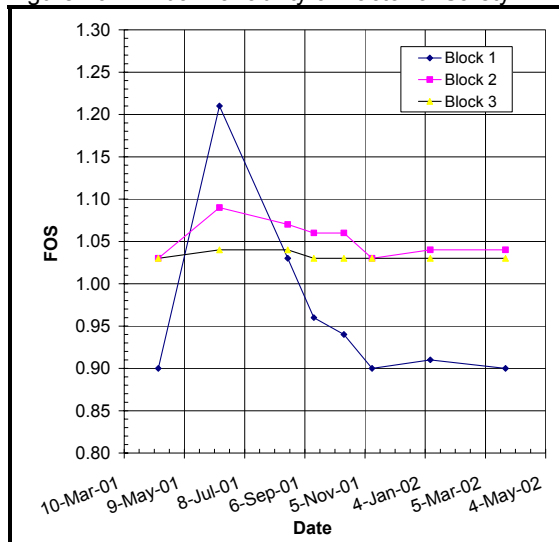
Figure 10: Annual Variability of Factor of Safety

Figure 10 suggests that the river water toe load has the greatest influence at the slide toe, where the calculated factor of safety varied by approximately 30 percent between the high and low water condition. At Block 2, which encompasses the soil mass between the ditch line and the toe of the slide, the factor of safety only varied by 6 percent, while the factor of safety for blocks extending further up the slope only changed by 1-2 percent throughout the year.
