CONTROLS ON STABILITY OF THE THOMPSON RIVER LANDSLIDES

M.J. Porter¹, K.W. Savigny¹, T.R. Keegan², C.M. Bunce³, and C. MacKay³

¹BGC Engineering Inc., Vancouver, British Columbia, Canada

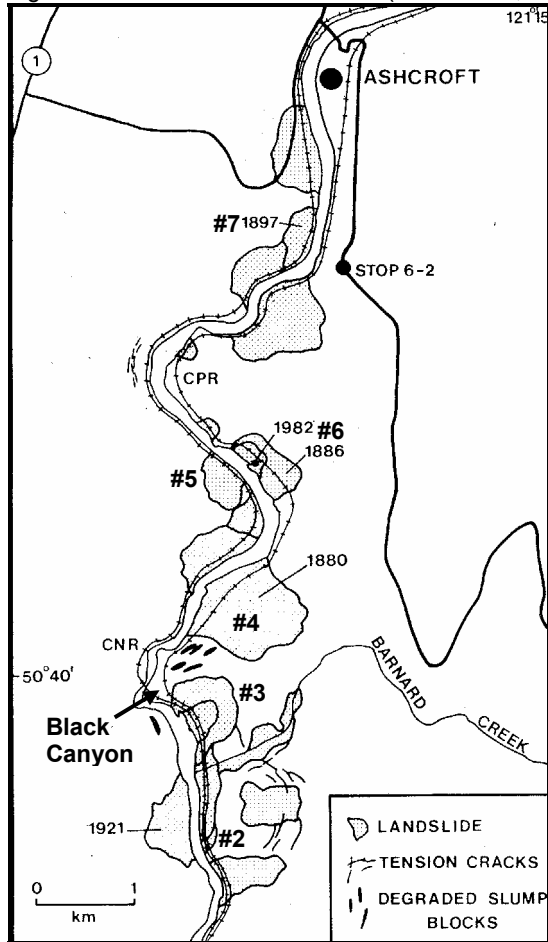
Figure 2: Landslides near Ashcroft (after Evans, 1987)

Following the Fraser Glaciation, the Thompson River rapidly downcut through the glacial sediments, forming a series of fluvial terraces in the process. Where downcutting of post-glacial Thompson River encountered high plastic clay deposits (presumably deposited in an old pre-glacial valley), large landslides often resulted (Figure 2). Elsewhere, steep erosional slopes stand with little evidence of deep-seated instability.

Note: numbers identify landslides listed in Table 1

- 1921 – may have triggered a landslide across from Nepa Slide (Figure 2);
- 1972 and 1974 – may have triggered reactivation at Nepa, South Slide, Goddard and Ashcroft 51 (Table 1); and,
- 1997 and 1999 – linked to reactivation at Nepa and South Slide, and possibly North Slide and Ashcroft 51.
